THE HOLLAND TRANSPLANTER, FURTHER MODIFICATIONS
OF THE -SHOE TO IMPROVE ROOT POSITION

Karl B. Lanquist
Nurseryman, Mt. Shasta Nursery, U.S.F.S.
McCloud, Calif.

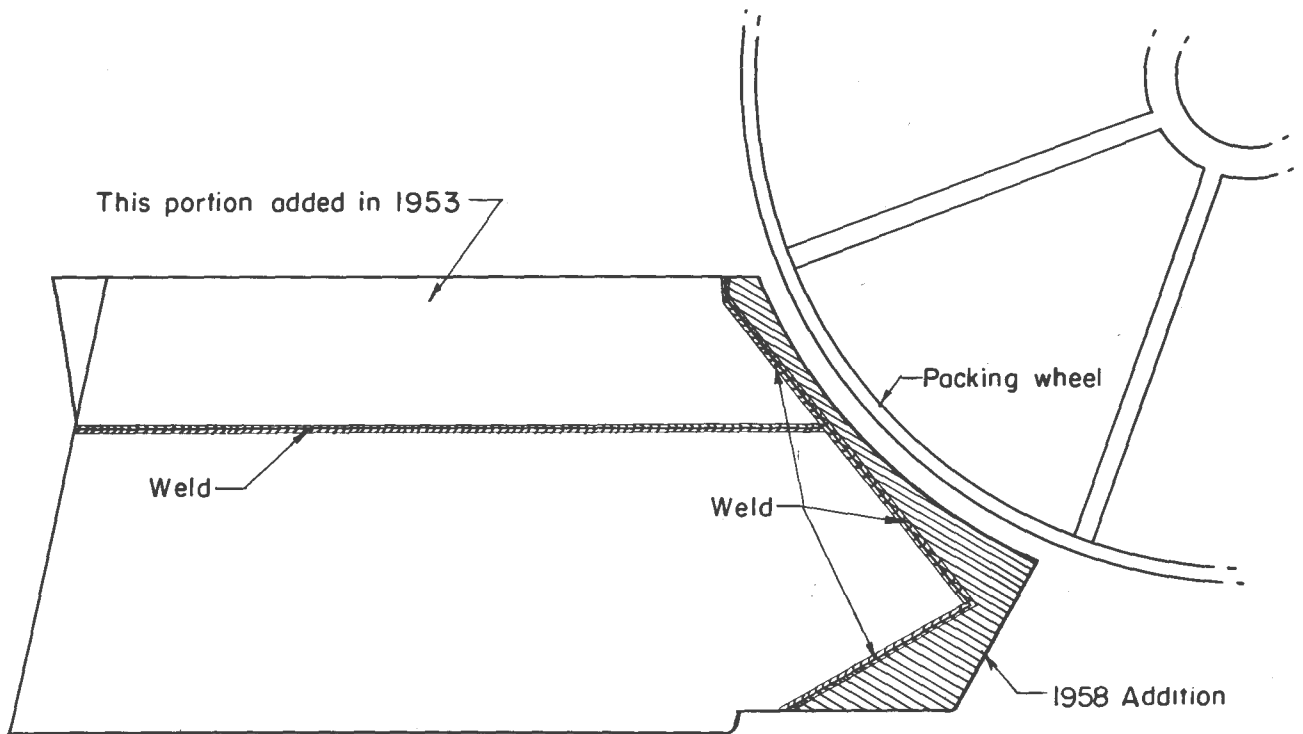
The March 1954 issue of Tree Planters' Notes carried an article on modifications developed at that time on the Holland transplant machine. However, further improvements are now necessary because: (1) The shoe did not complete the trench in time for the tree to be released and secured by the packing wheel, and (2) soil shifted in between the upper half of the shoe and the packing wheel. To correct these defects we found it necessary to add (fig. 1):

Figure 1.--Shoe modification for Holland transplanter.

- A. To the depth of the shoe.
- B. About 3 inches to the length of the shoe.
- C. A strip close to the packing wheel.

As a result of these changes, planting will be well done if the roots are all pruned to about the same length, and if the trees are placed in the same and correct position in the rubber clips. The problem of bent roots should not occur.
