# Coyote Willow Pole Plantings in Ephemeral Streams of Southwest New Mexico

Erin Evans

Partner, Heartstone Angus, LLC, Silver City, NM

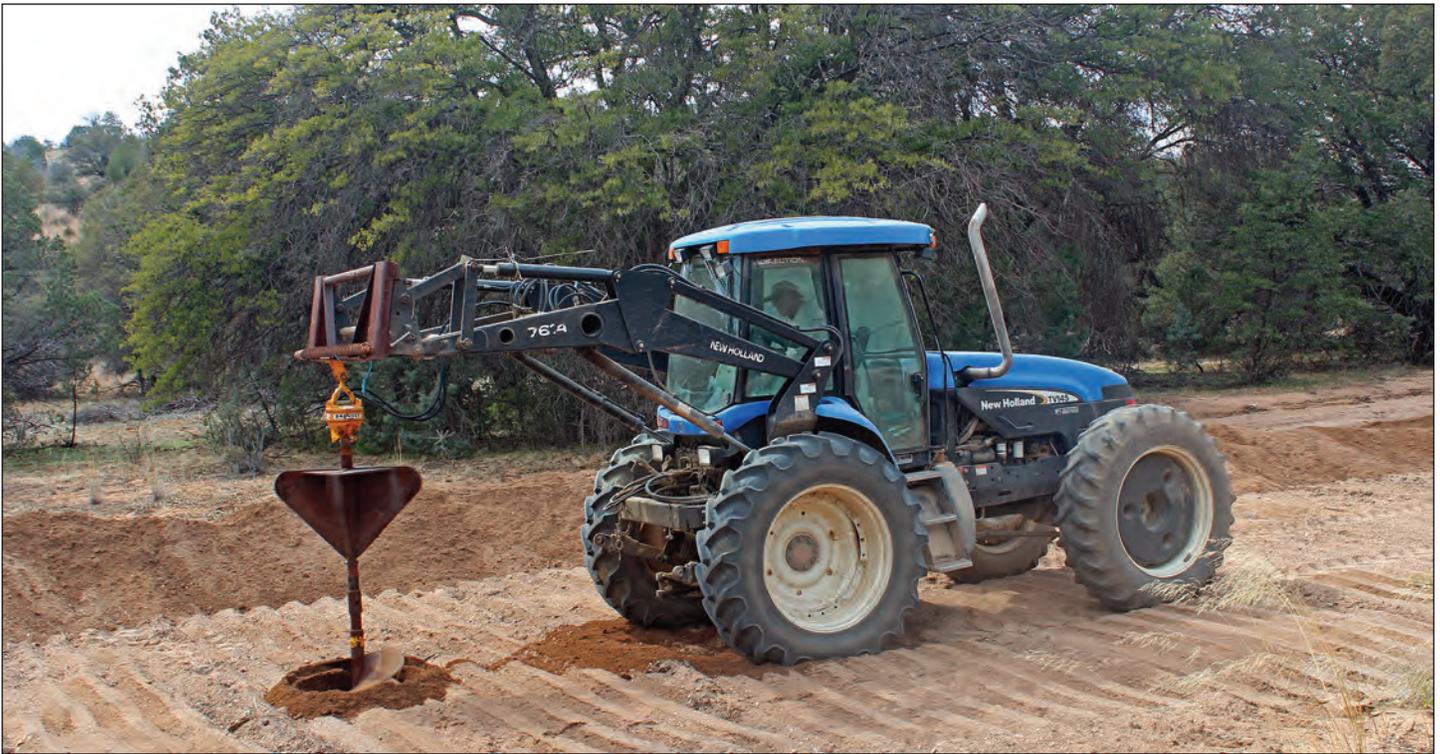
**Figure 1.** Augers were used to create planting holes that were deep enough for the coyote willow poles. (Photo by Erin Evans, 2012)

Coyote willow poles were at least 8-ft long and had an approximately 1-in diameter (but not less than 0.75-in or more than 1.25-in) with all the upper growth cut off. We drilled the planting holes 6 ft deep with either a handheld auger or a tractor-mounted auger (figure 1), depending on site accessibility. Planting was done in January and February, before the coyote willow broke bud. We planted the poles as deep as we could get them in the holes, leaving 12 to 15 in aboveground (figure 2).

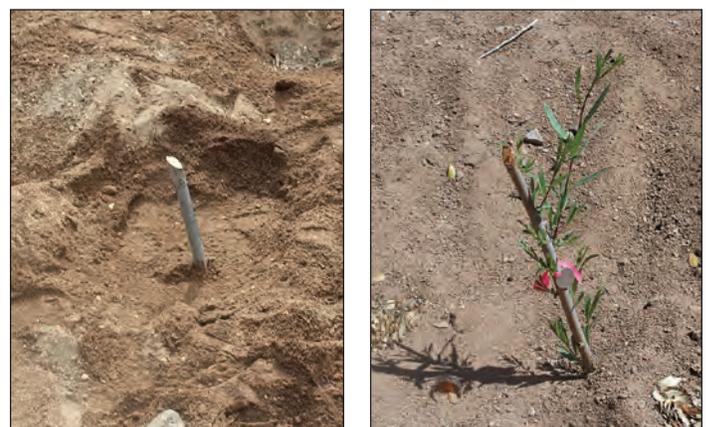
**Figure 2.** Coyote willow poles were planted as deeply as possible, leaving just the top 12 to 15 inches aboveground. (Photos by Erin Evans, 2012)

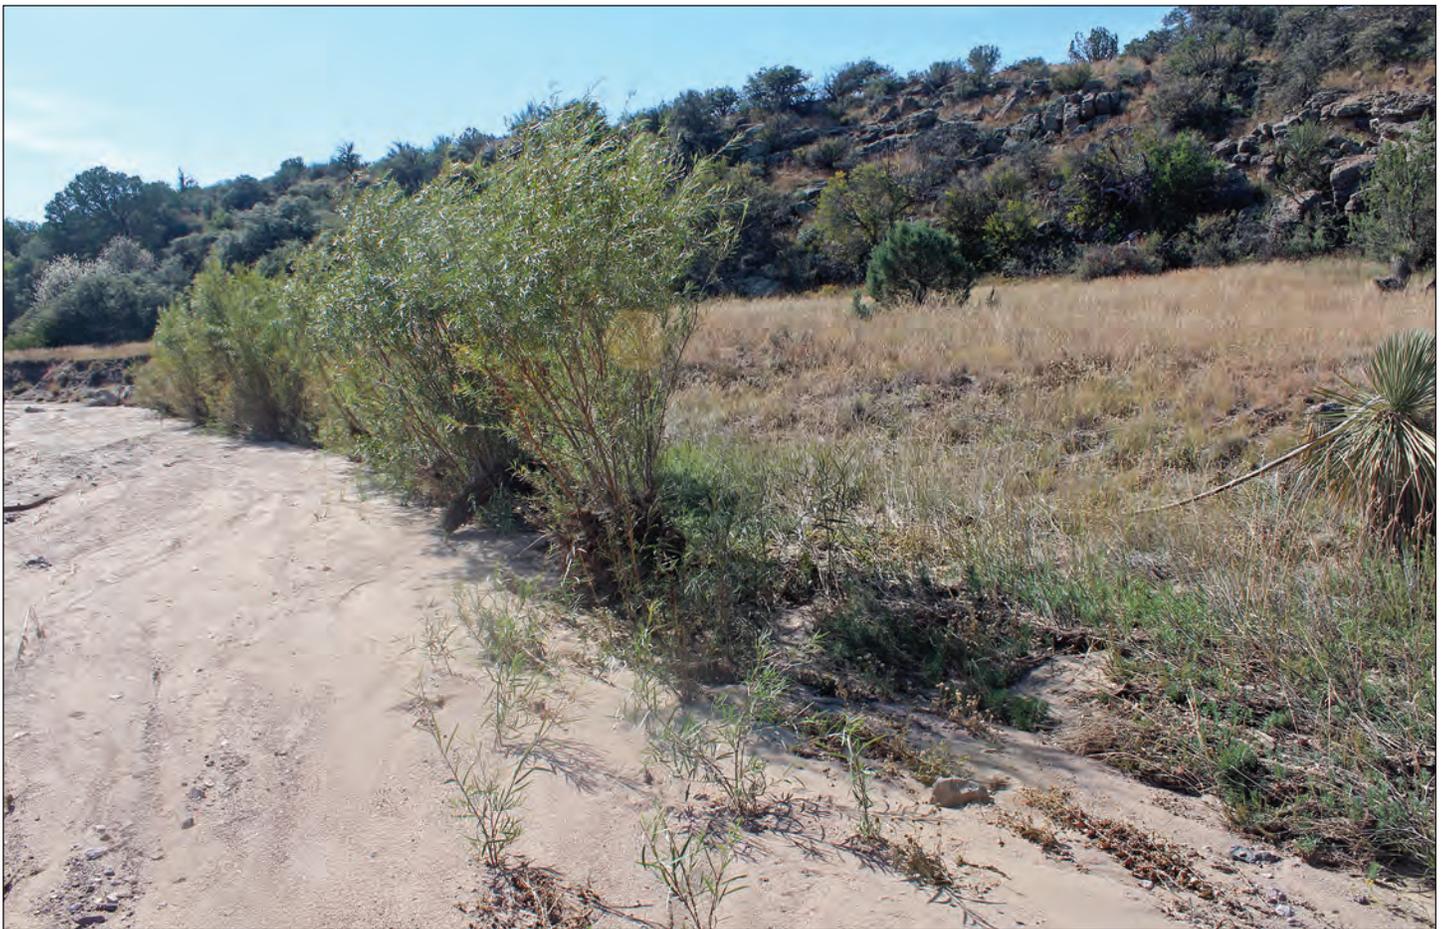
**Figure 3.** Coyote willows planted in 2012 armor a bank at the top of Walking X Canyon. Four years later, erosion has been mitigated, grass has been reestablished on the bank, and the willows have put out numerous suckers. (Photo by Erin Evans, 2016)

For the second planting (2012), we revised the planting methods and site selection. We chose two locations near each other that had similar water table heights and waterflow rates during precipitation events. The locations were about 2 miles upstream from the first planting. A neighbor routinely overgrazes their land, resulting in significant flood waters from their side of the fence into our main channel when there is a heavy rain. A rock wall on one side of the canyon deflects the water to the opposite floodplain bank, rapidly eroding the streambank. We planted coyote willow poles along the most vulnerable area of the bank. Pole characteristics and source were the same as the first planting. After a few years, the bank is very stable, the willows are large, and the grass has grown as well (figure 3).

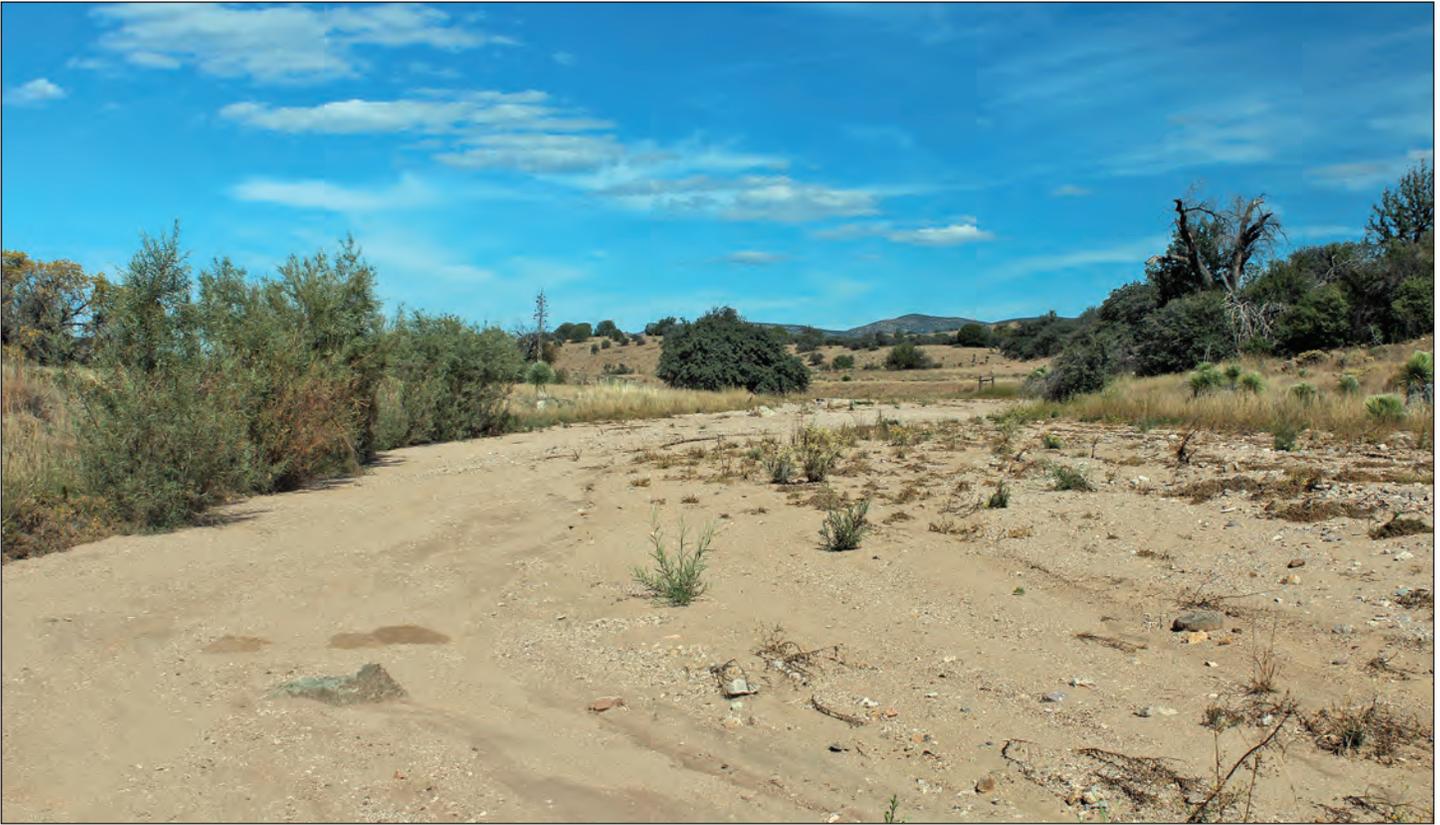
**Figure 4.** Diagonal rows were planted adjacent to the armored bank in 2013 but were covered by sediment after a major flood event. Two years later, however, the planted coyote willows had emerged from the sand. (Photo by Erin Evans, 2016)

We continued the same planting strategy in an adjacent area in 2013 by planting poles in diagonal rows across the same channel. The first year after planting, the poles were buried by sediment from a flood event. Two years later, however, the poles emerged from the sand

and are now armoring the wash adjacent to the previous planting (figure 4).

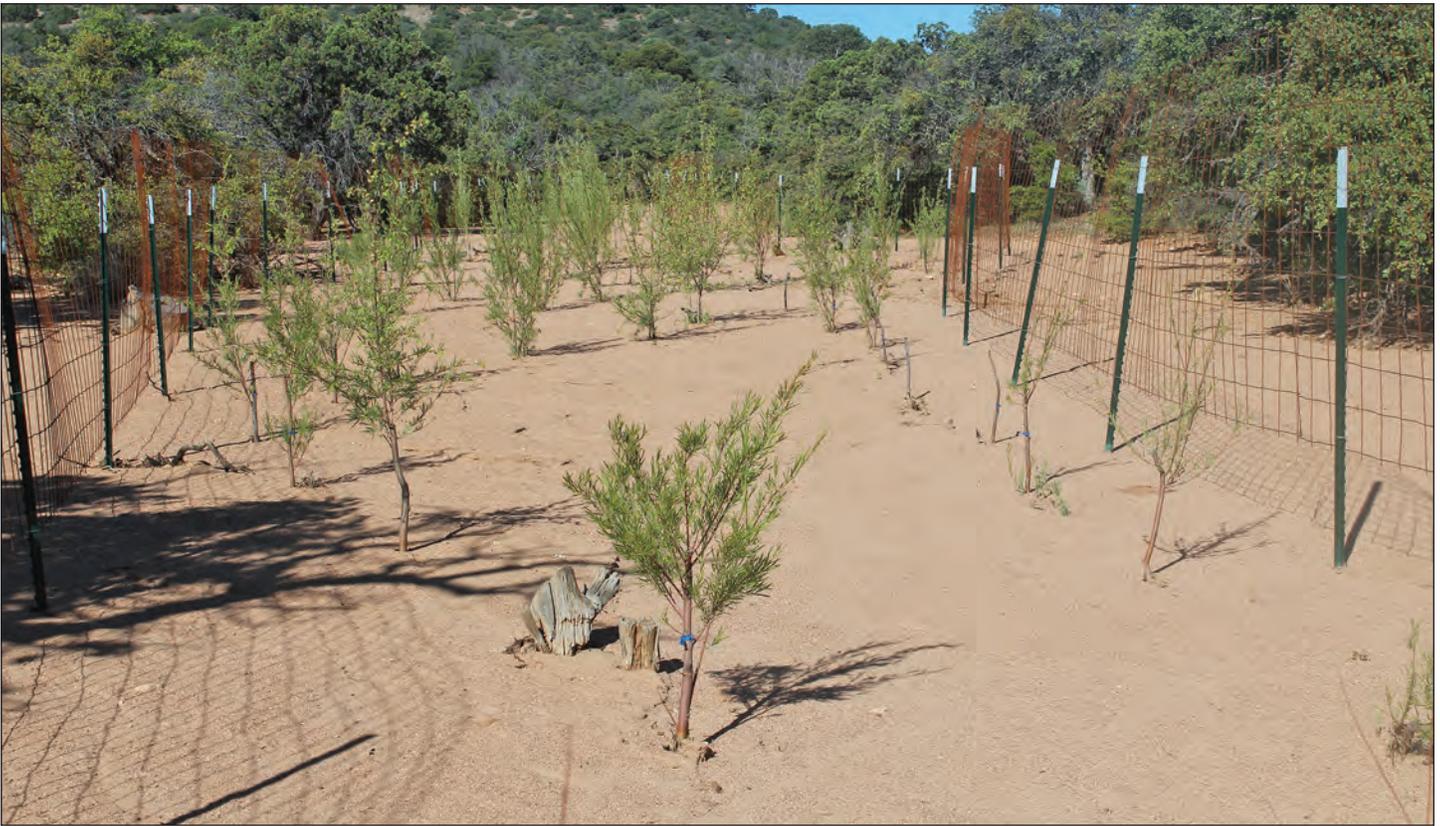
**Figure 5.** These coyote willow poles were installed on the Gila National Forest in 2017. Three years later, the suckers can be seen along with the protective fencing installed to guard against herbivory. (Photo by Erin Evans, 2020)

We have initiated similar experimental plots on the Gila National Forest, several of which have failed due to both elk predation and flooding. One notable success is in a wash with significant erosion potential. In 2017, we began planting at the top of this area which had a shallow sand base sitting on bedrock. Some pole mortality occurred in this upper area. Further downstream were varying depths of bedrock, which influenced where we planted the poles. When we got to an area where we could drill at least 4 ft deep, we planted the poles about 6 ft apart. In every case, there was water in the hole, but we were working in sandy sediments. We fenced this area to prevent elk predation, installing the fence high enough above the wash surface so flood water would not destroy it. After 5 years, the planting is doing well (figure 5).
