## GRAFTED YELLOW-POPLAR RAMETS DAMAGED BY BORERS

Newton R. Churchwell Tennessee Division of Forestry, Jackson, Tenn.

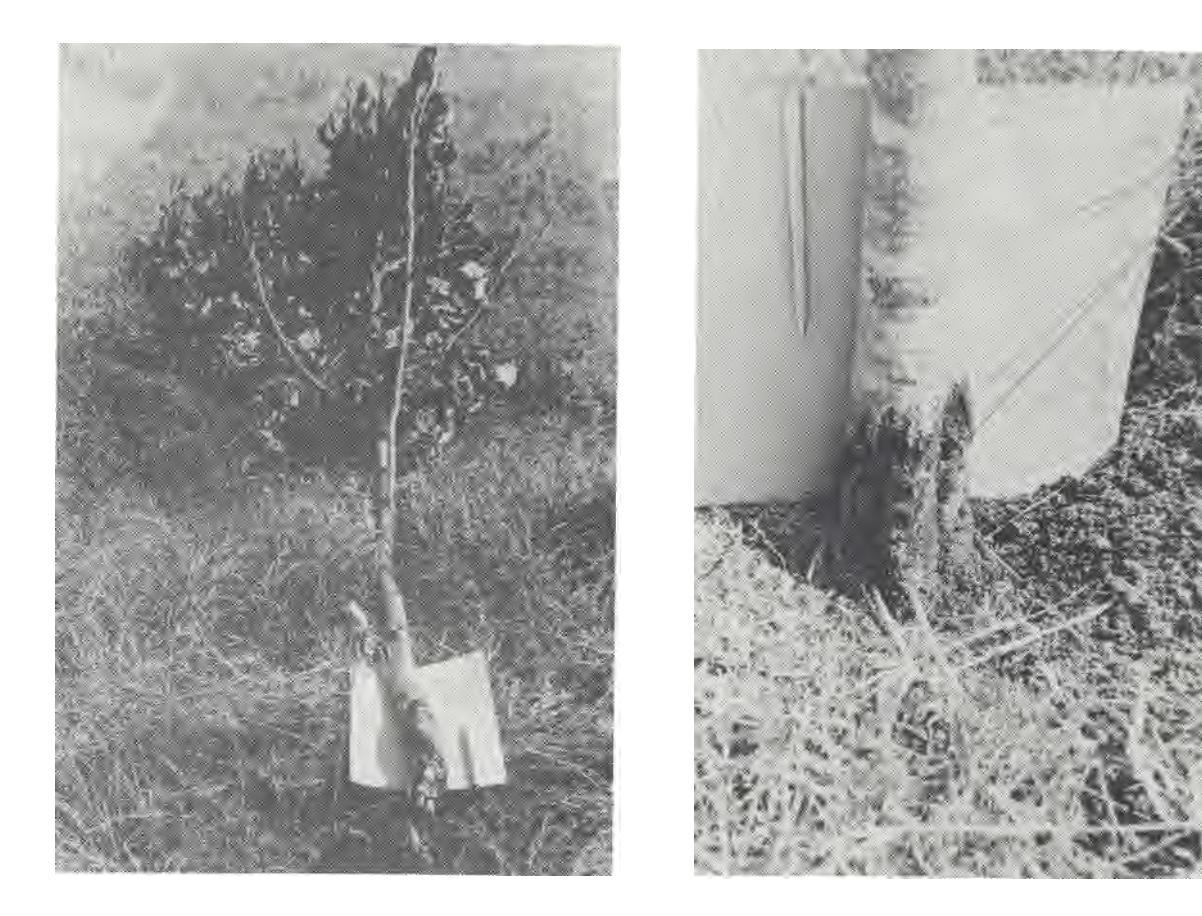
Flat and slightly darkened places were noted on the bark and often extended up the stem after the borers had been present long enough for the affected area above their tunnels to die.

The damage was done to the cambium, inner bark, and immediately adjacent tissues upon which the larva feed. When a knife was inserted into the tunnel, it was very often found that the larva were working in a chamber up to 2 square inches in size, and extending well below the ground line. As many as 10 larva were taken from one tree.

Figure 1.--(A) This tree was almost completely gridled by borers. Not enough live tissue was left to keep the tree alive until the wounds could heal. (B) Narrow strips of live tissue was left between borer damage on this tree. Healing is good, and the wounds will soon be covered.

Various insecticides were used in an effort to control the insect. A borer spray manufactured by Ortho Chemical Company, recommended for peach tree borers, was used. Also, a 50 percent wettable DDT powder was sprinkled on and around the root collar. A systemic, Thimet, was added to help control further infestation during the year. Three days after the various treatments had been applied, the borers were still found to be active. The next step was to make a tree to tree search and dig the larva out with a knife. This can be a tedious job. No more of the live bark should be removed than is absolutely necessary. Often the damage from four or five larva completely encircle the tree. If the borers are small and have not eaten the newly formed cortex, their feeding tunnel will be bridged over by fast growing trees and actual damage will be held to a mlnimum at that point. The larva resemble the dogwood borers in appearance but not in their activity. There were no signs of borers in prunning wounds or points of contact between branches and stem as is characteristic of the dogwood borer. Also, the tunnels do not extend into the Xylem. (See figure 1 below).

A spray program using a 25 percent emulsified DDT solution was carried out on the live grafts through July and August to control potential damage from this and other insects.
