Revegetation of Reconstructed Reaches of the Provo River, Heber Valley, Utah

John A. Rice

In: Riley, L. E.; Dumroese, R. K.; Landis, T. D., tech. coords. 2006. National Proceedings: Forest and Conservation Nursery Associations-2005. Proc. RMRS-P-43. Fort Collins, CO: U.S. Department of Agriculture, Forest Service, Rocky Mountain Research Station. 160 p. Available at: <http://www.rngr.net/nurseries/publications/proceedings>

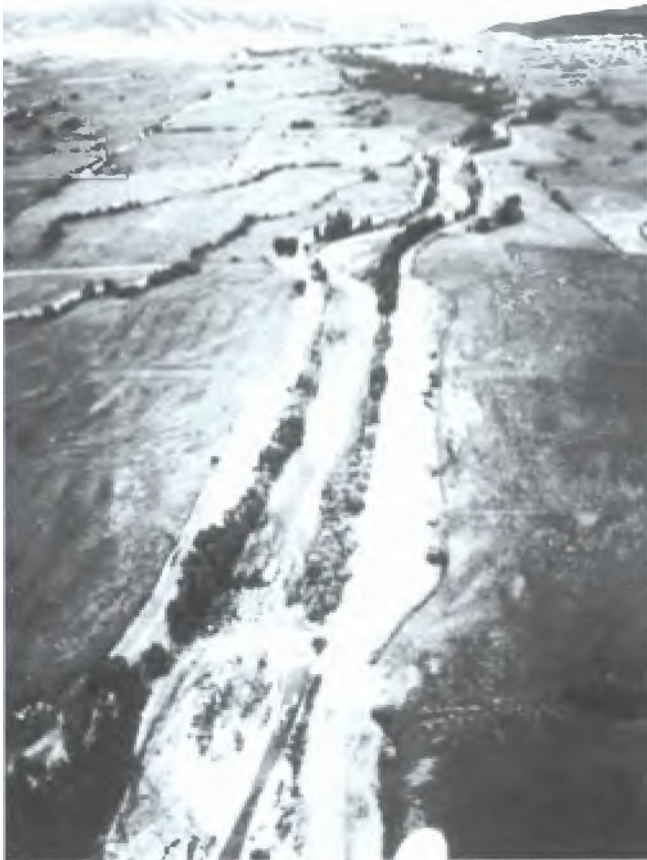
Figure 1—Provo River in Heber Valley before restoration.

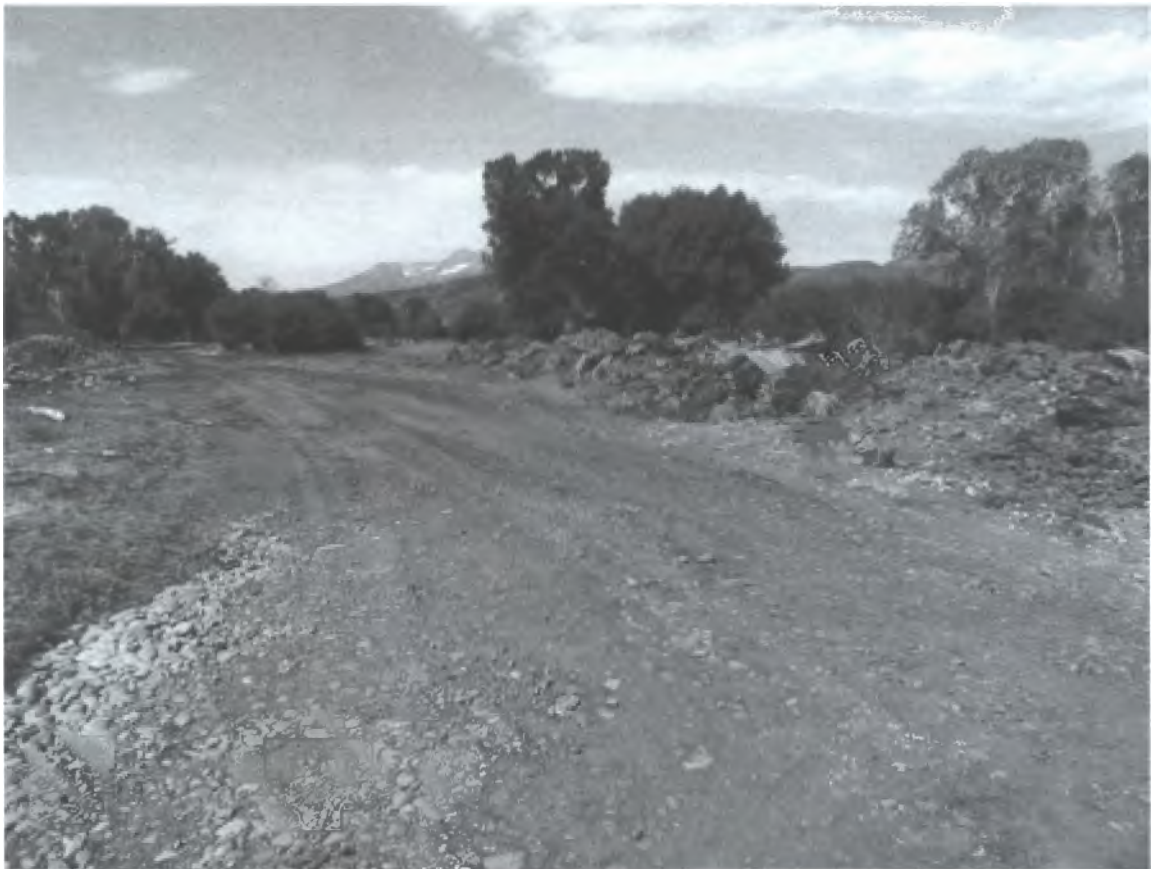
Figure 2—P R R P haul route. Note that the top foot of soil, which contains plant roots and seeds, has been stockpiled to the right of the road. This minimizes handling of the topsoil. Decommissioning of the route would follow the sequence of removing any road fill, grading to establish proper contour, ripping (if necessary), and replacement of topsoil.

Haul routes were minimized, and, to the maximum extent practicable, did not cross wetlands, wet areas, or constructed features. If crossing a constructed feature became necessary, compacted areas were ripped prior to topsoiling. No crossing was permissible on topsoiled areas (figure 2).

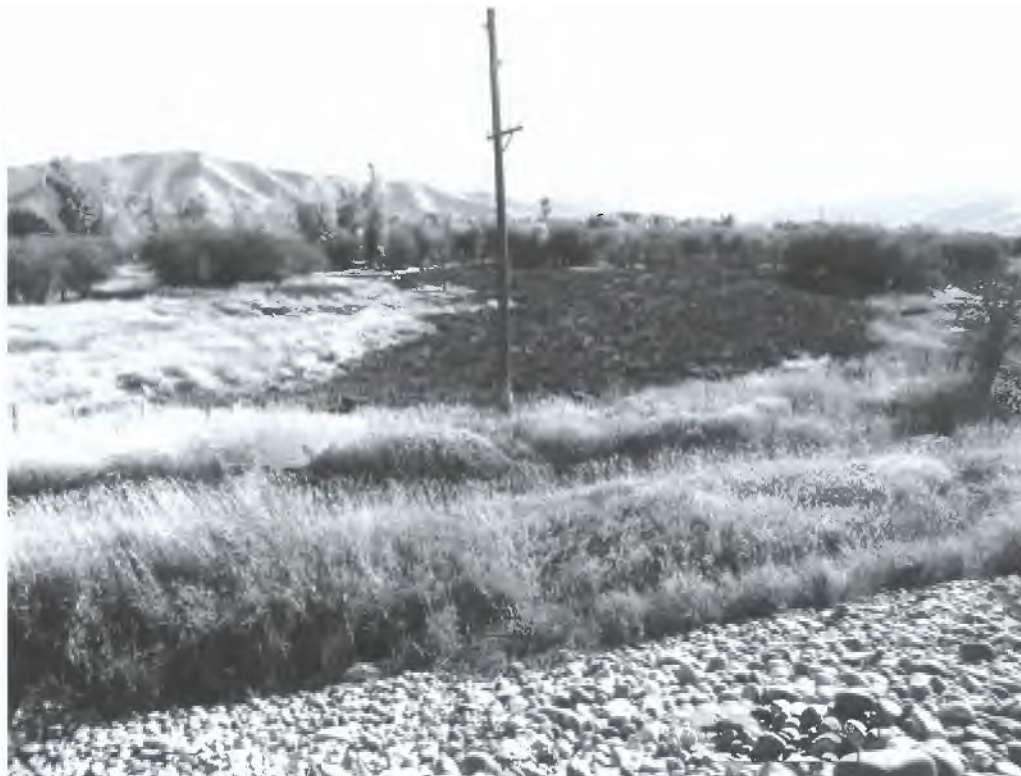
Figure 3—Small mammal refuge created by ONS e disposal of excess material.

Onsite disposal of excess material can cause site impacts by disturbing additional area and possibly covering productive habitat. However, careful dispersal of excess material onsite will not only avoid transportation costs, but can reclaim disturbed habitats. For example, PRRP small mammal studies indicated that upland habitat for small mammals might be in short supply during high water events associated with periodic floods. For this reason, excess material has been used to raise the elevation of uplands in several areas in order to provide a refuge during high water events (figure 3).

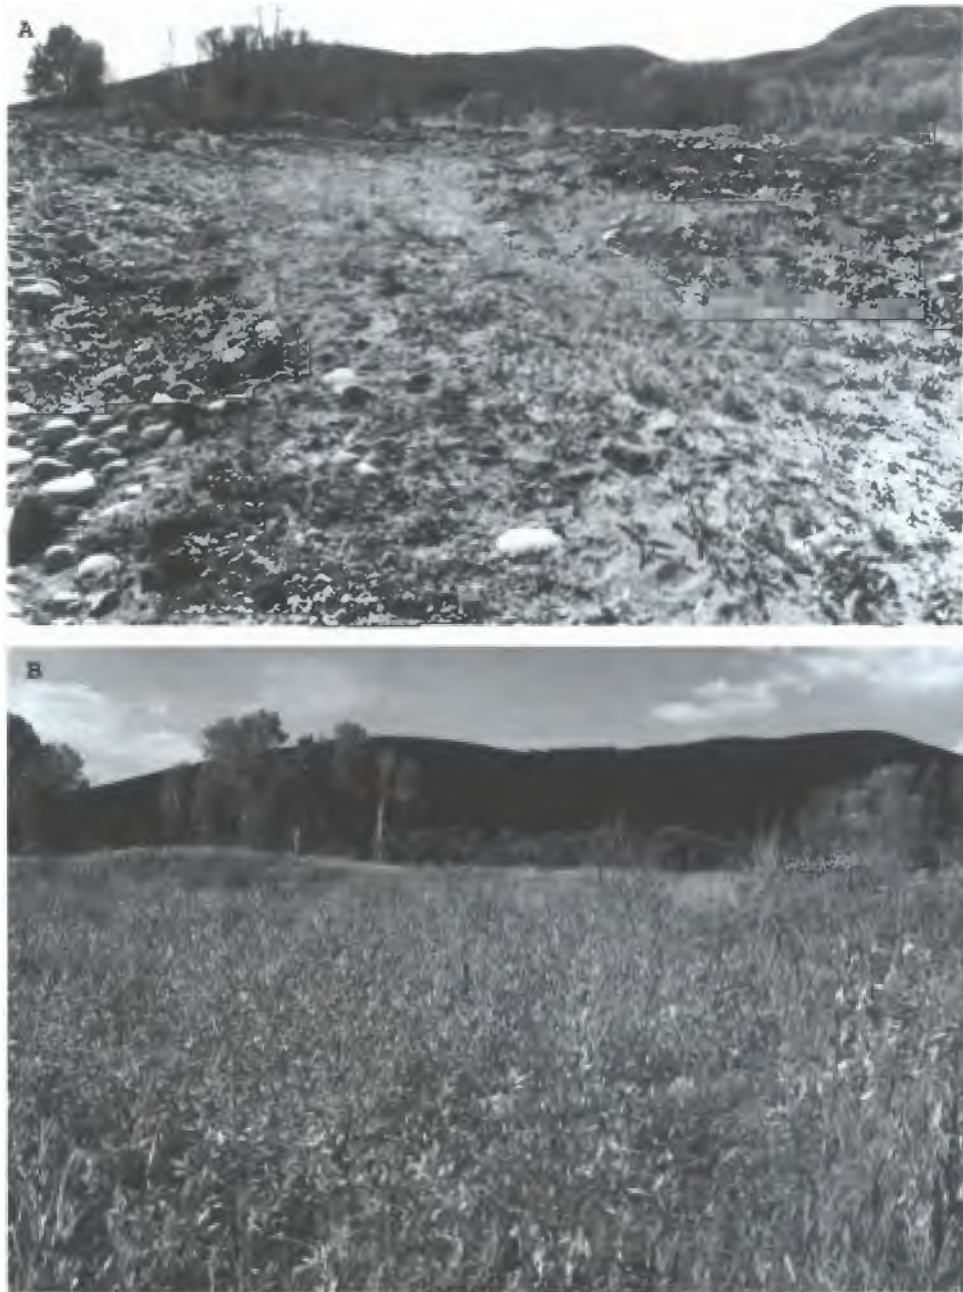
Figure 4—High flow channel one flood event after construction (A) and three flood events following construction (B). Note that no trees or shrubs have been installed at this location. Natural recruitment accounts for the many hundreds of seedlings.

Wherever possible, it was important to work with the natural disturbance regime of the river. Figure 4a shows the natural recruitment of hundreds of seedlings within a high flow channel following a single flood event, and figure 4b the natural recruitment of hundreds, if not thousands, of seedlings following three flood events. No trees or shrubs were

installed at this location, yet several cohorts of willow and cottonwood have successfully established because the natural disturbance regime of the river has been reestablished.
